RECLAMATION REPORT

ORPHAN MINE

GRAND CANYON NATIONAL PARK, ARIZONA

June 1986

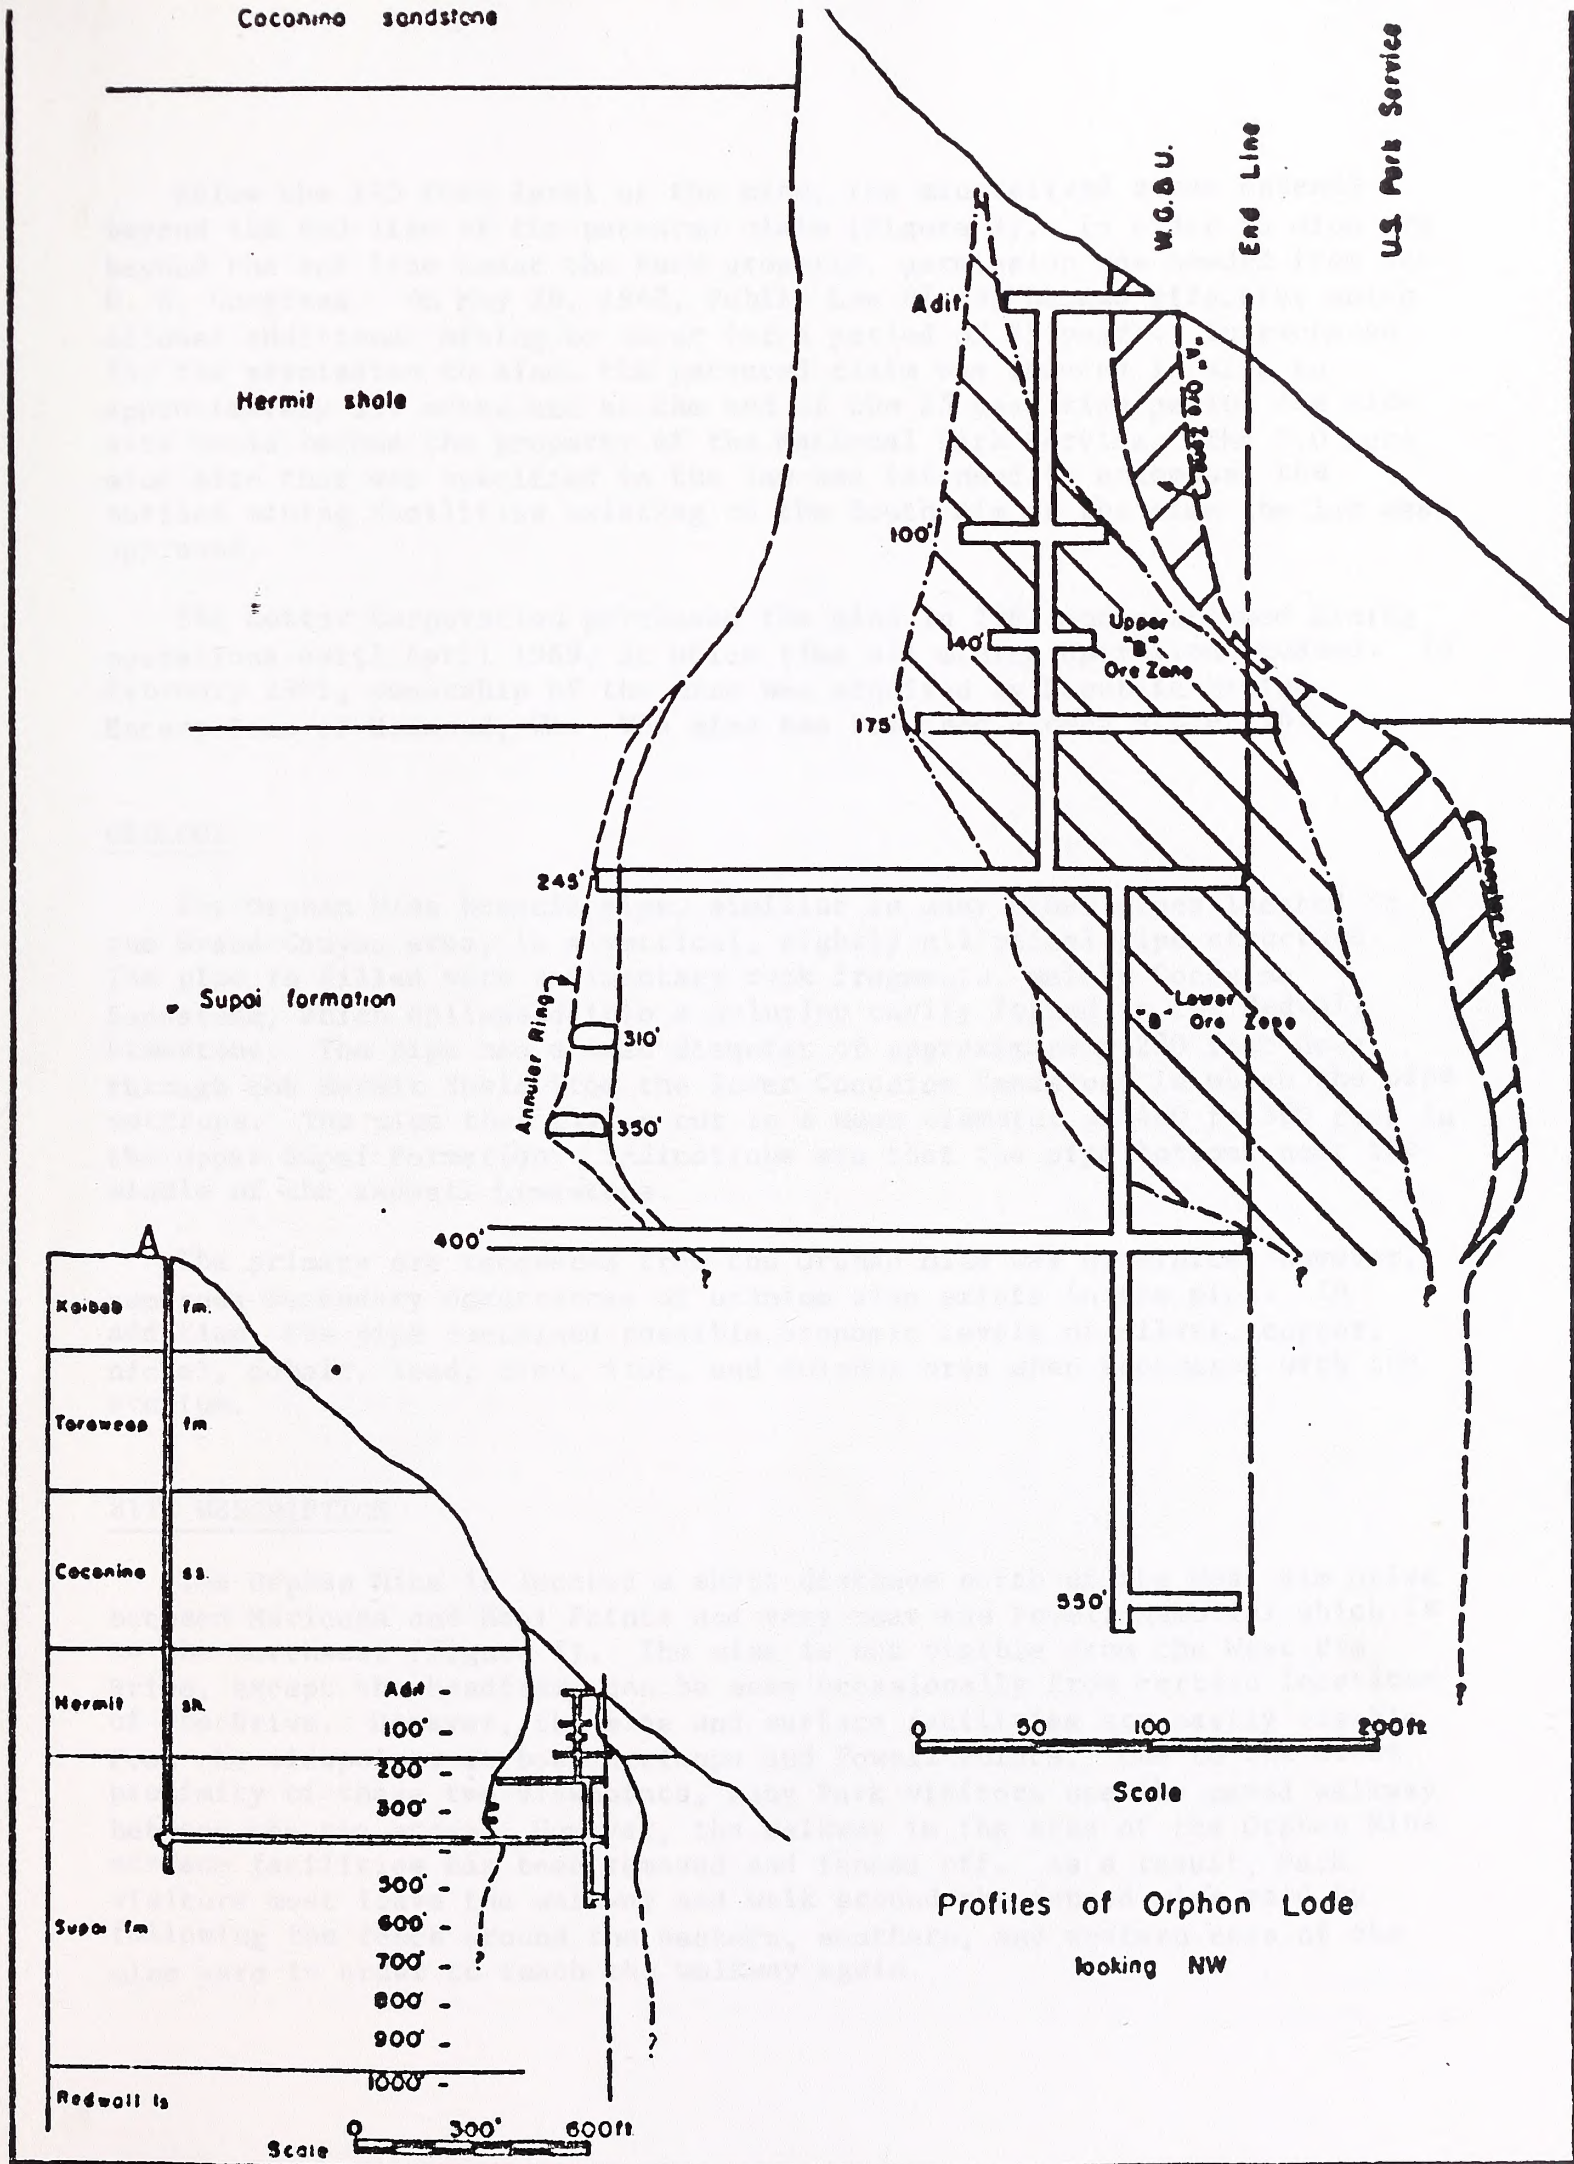
Figure 3 Orphan Lode Coconino County, Arizona

Below the 175 foot level of the mine, the mineralized zones extends beyond the end line of the patented claim (Figure 3). In order to mine ore beyond the end line under the Park property, permission was needed from the U. S. Congress. On May 28, 1962, Public Law 87-457 became effective which allowed additional mining to occur for a period of 25 years. In exchange for the permission to mine, the patented claim was reduced in size to approximately 3.0 acres and at the end of the 25 year time period the mine site would become the property of the National Park Service. The 3.0 acre mine site that was specified in the law was intended to encompass the surface mining facilities existing on the South Rim at the time the law was approved.

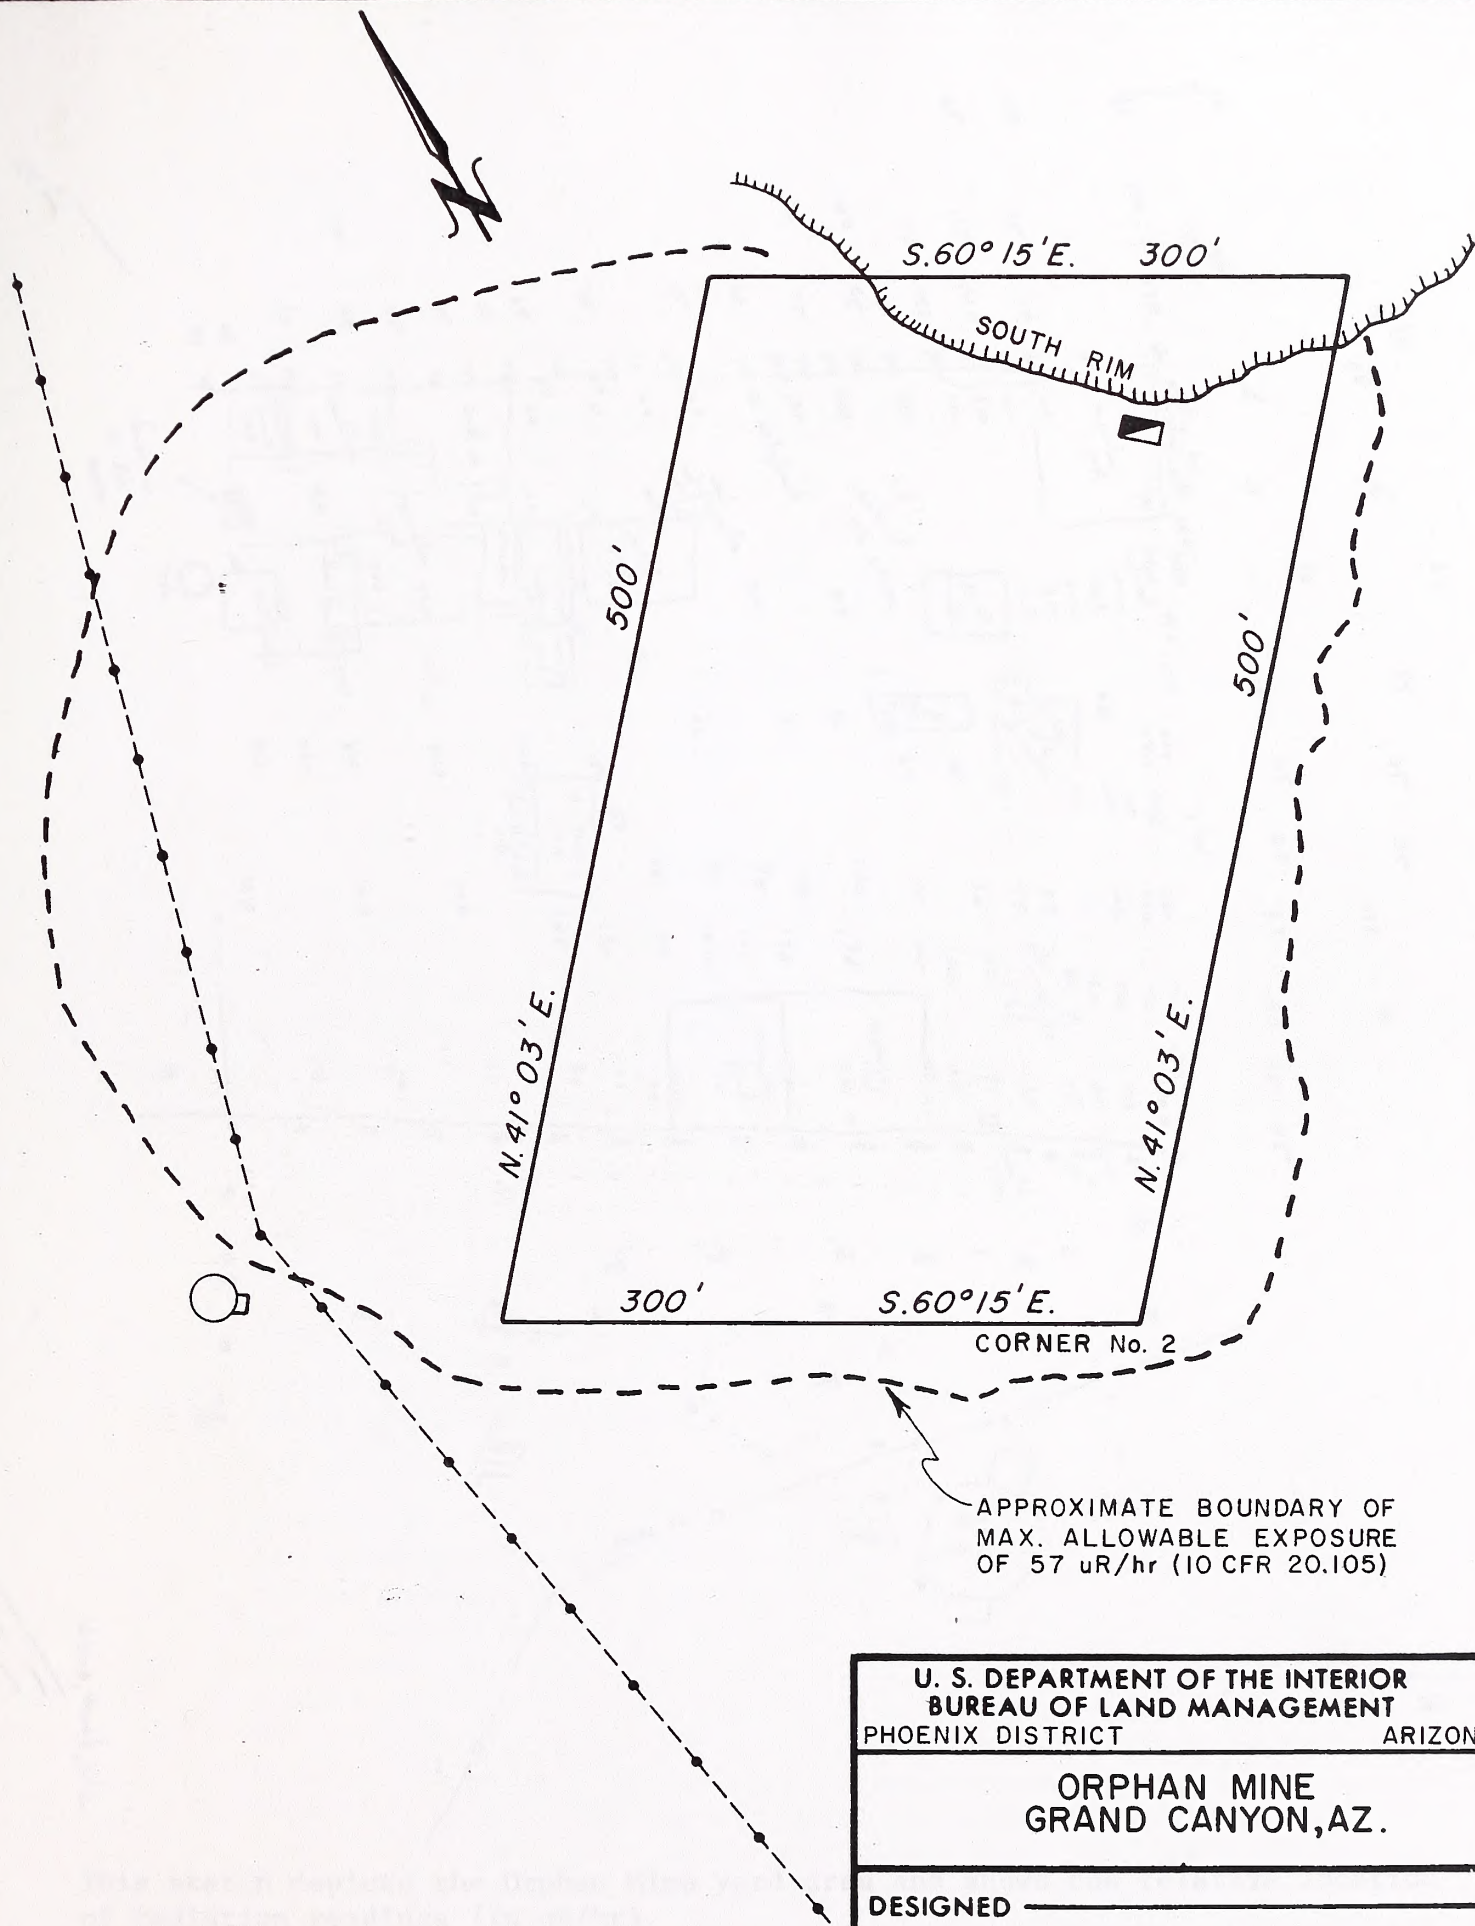
FIGURE - 4

4. **SHAFT AND CONTAMINATED MATERIALS.** Based upon the BLM radiological survey, the area in and around the mine yard is emitting low levels of radiation. Two explanations of the source of the low level radiation would be that material from the mine was used as fill when the mine yard site was being prepared and/or the random scattering of uranium ore by men and equipment during the active mining periods. In addition, it appears that low level radioactive material was transported by wind and water action to the Park lands adjacent to the fenced mine yard. Please refer to Figure 4 which shows the area, approximately 5.6 acres in size, where contamination has occurred. Figure 5 is a sketch copy of the mine yard area which shows the readings taken during the radiological survey.

In order to minimize the exposure from this hazard, it is recommended that the area showing radiation levels greater than the amount specified by Part 20 of Title 10 of the Code of Federal

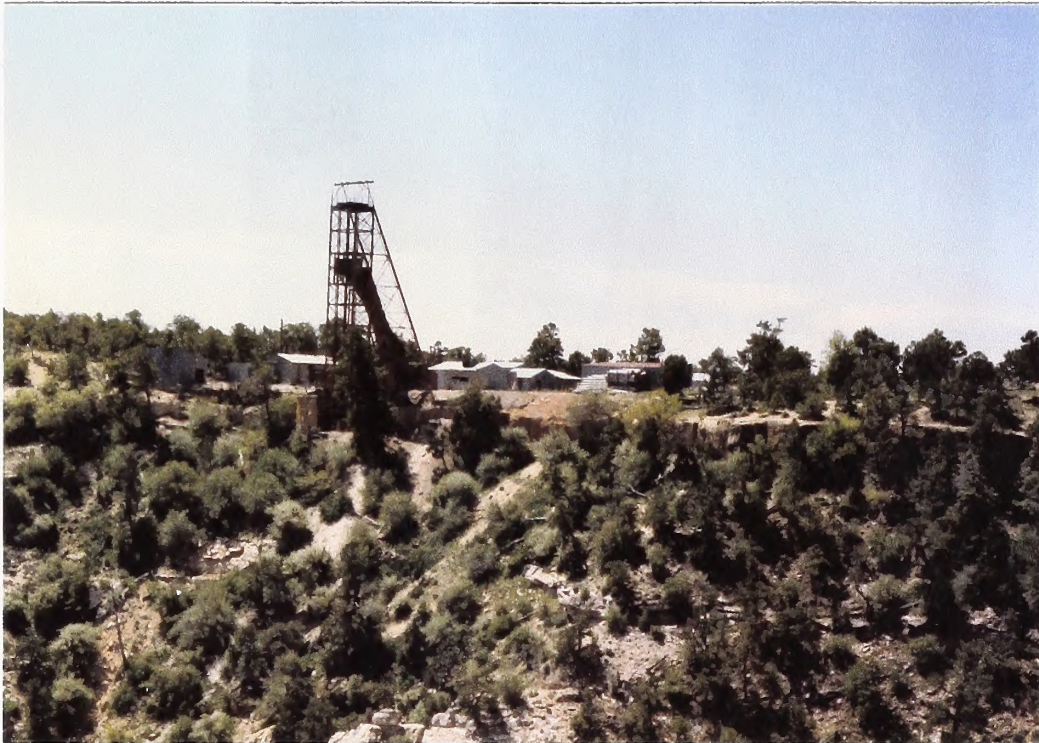
PHOTO #1: The view of the Orphan Mine facilities located on the South Rim of the Grand Canyon. The photo is taken from the Powell Memorial.

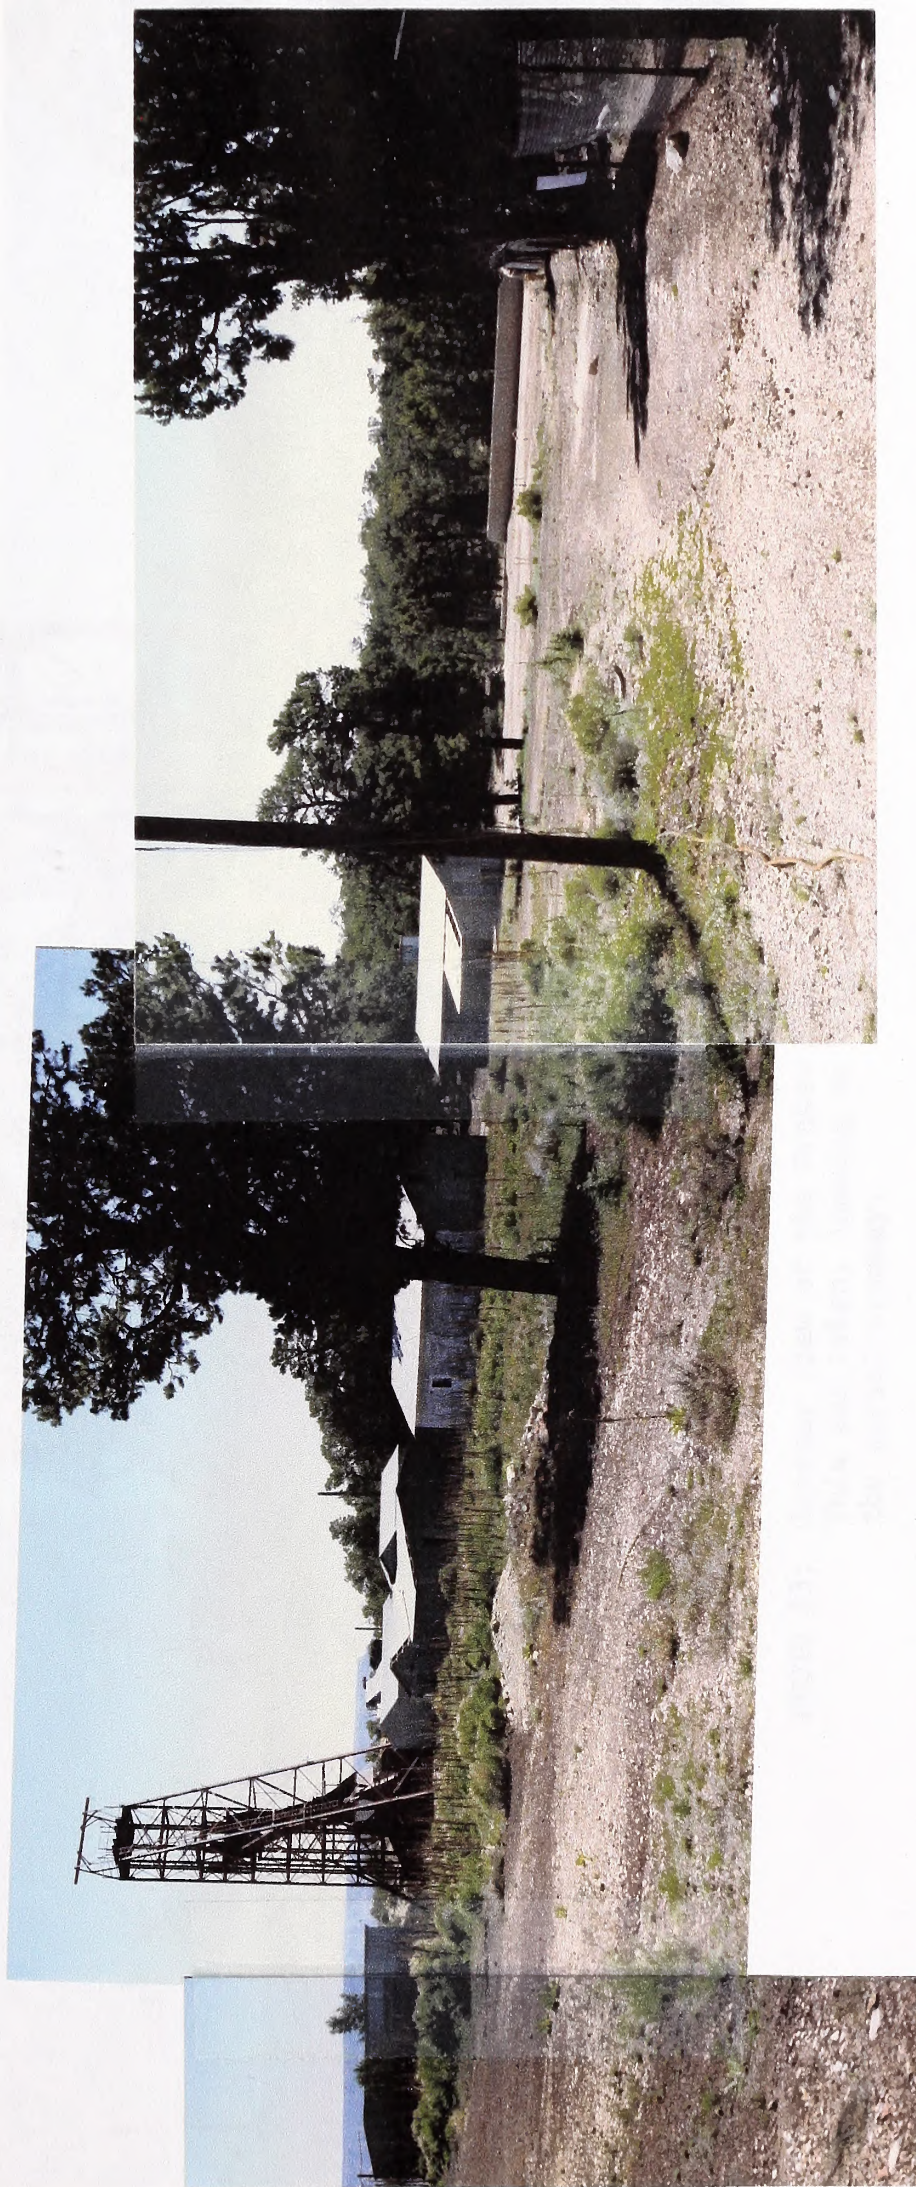
PHOTO #2: A view of the Orphan Mine facilities located on the South Rim. The photo was taken from the mine yard gate and is looking to the North.

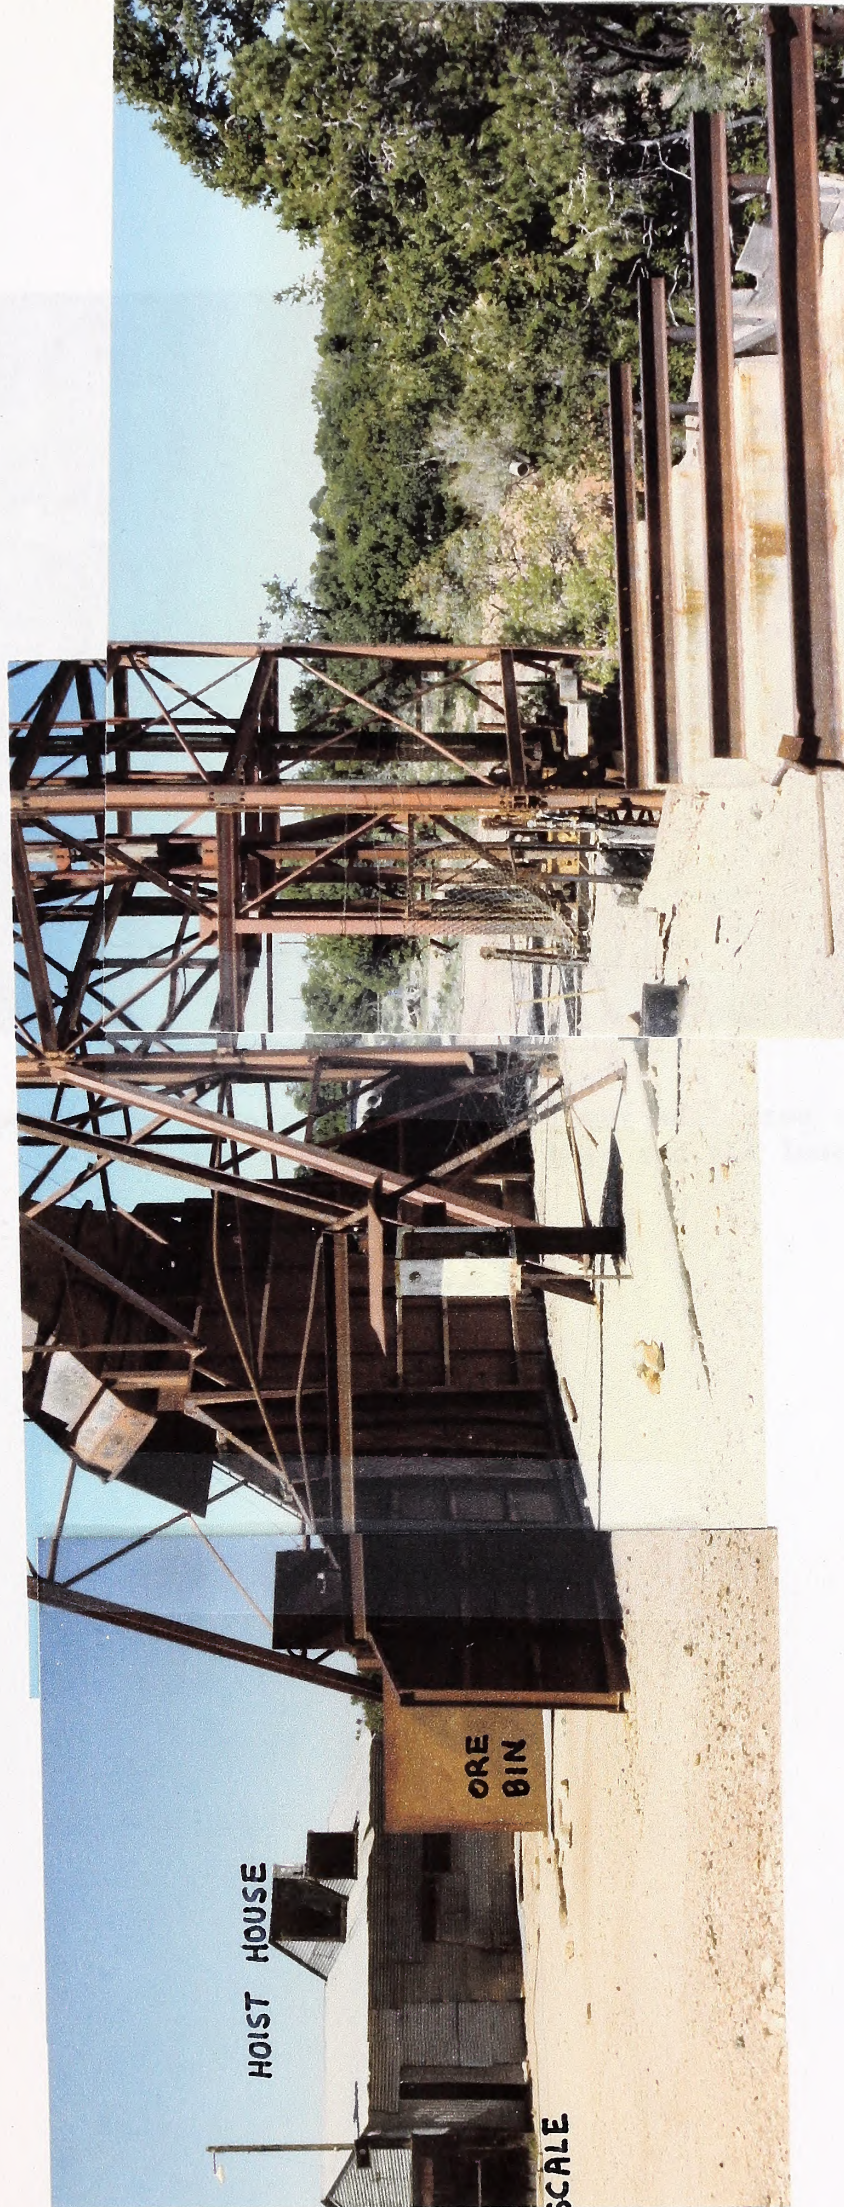
PHOTO #3: Another view of the Orphan Mine facilities on the South Rim. This was taken, looking to the south, from the foundation of the aerial tramway.
